AsktheBuilder.com

Deck Stain Test Results

Released April 14, 2013

Early Spring 2013

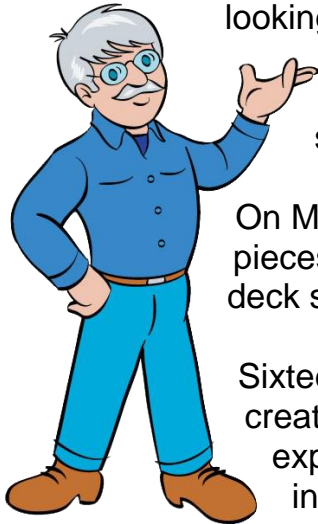
I decided I'd do a side-by-side test of as many deck stains / sealers that I could get my hands on.

On May 12, 2012 thirty-two pieces of cedar decking and thirty-two pieces of regular treated lumber were stained with off-the-shelf wood deck stains / sealers.

Sixteen different wood sealers / stains were used to coat the lumber creating two identical sample sets. One set was immediately exposed to the weather and the other set was boxed up and stored indoors away from sunlight and all weather.

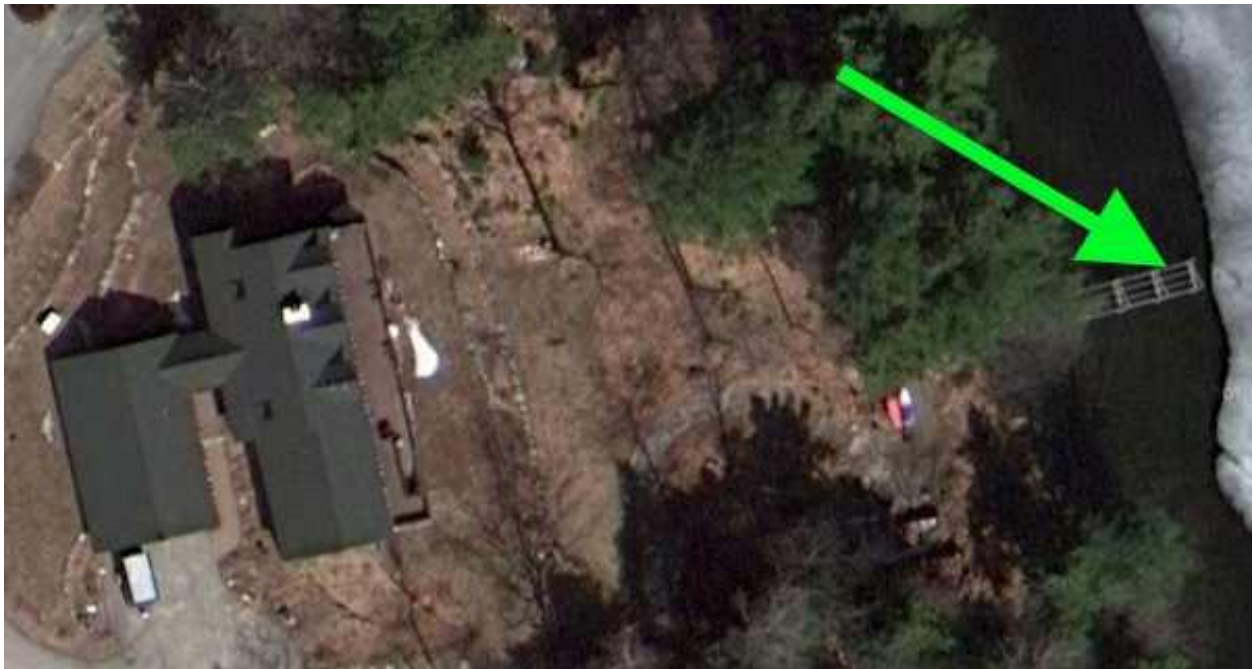
The pieces of wood exposed to the weather were set out on my dock on Lake Winnisquam in central New Hampshire. The shore line faces east, so the boards experienced brutal sunlight from dawn until mid-late afternoon.

The pieces of wood were set side-by-side on the dock separated by maybe 3 inches. In other words, the cedar and treated lumber each received identical amounts of sun, rain and shade.

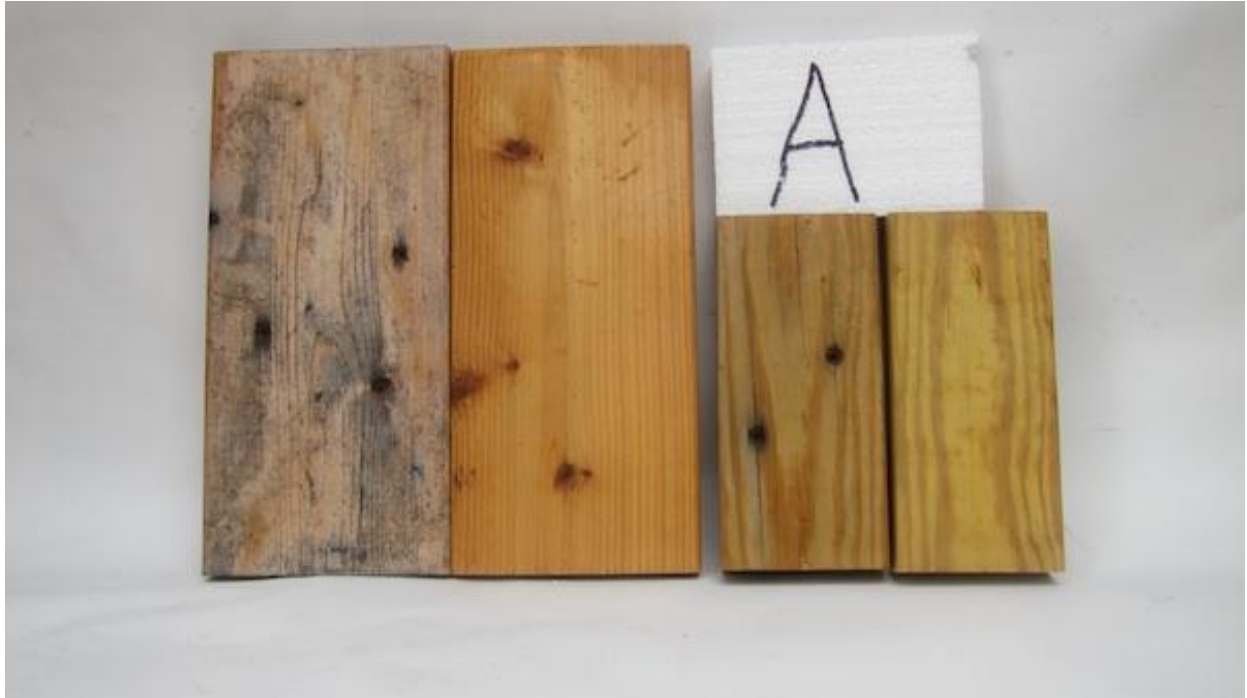
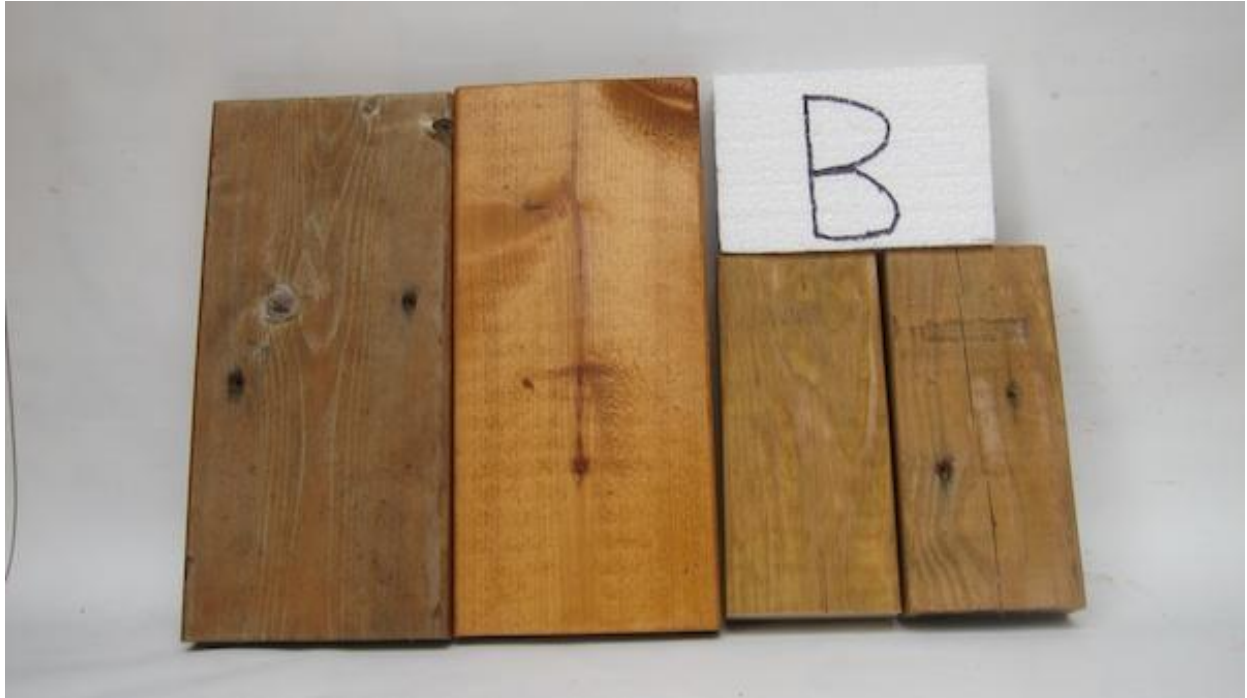
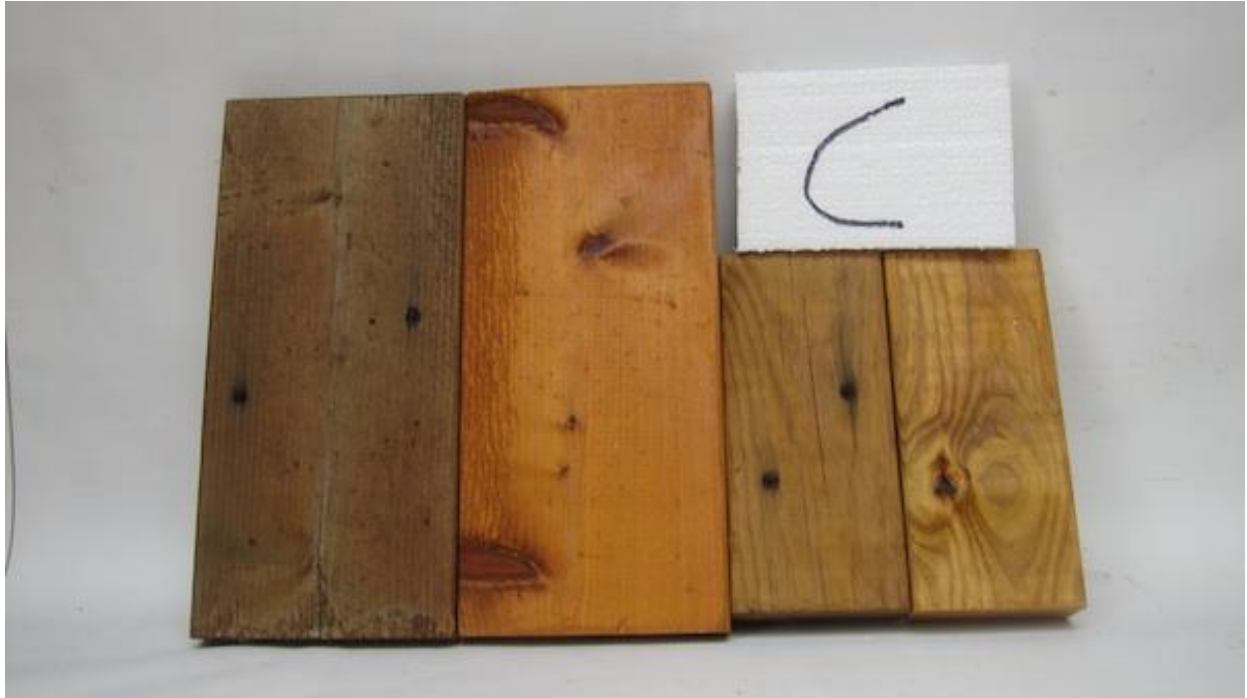
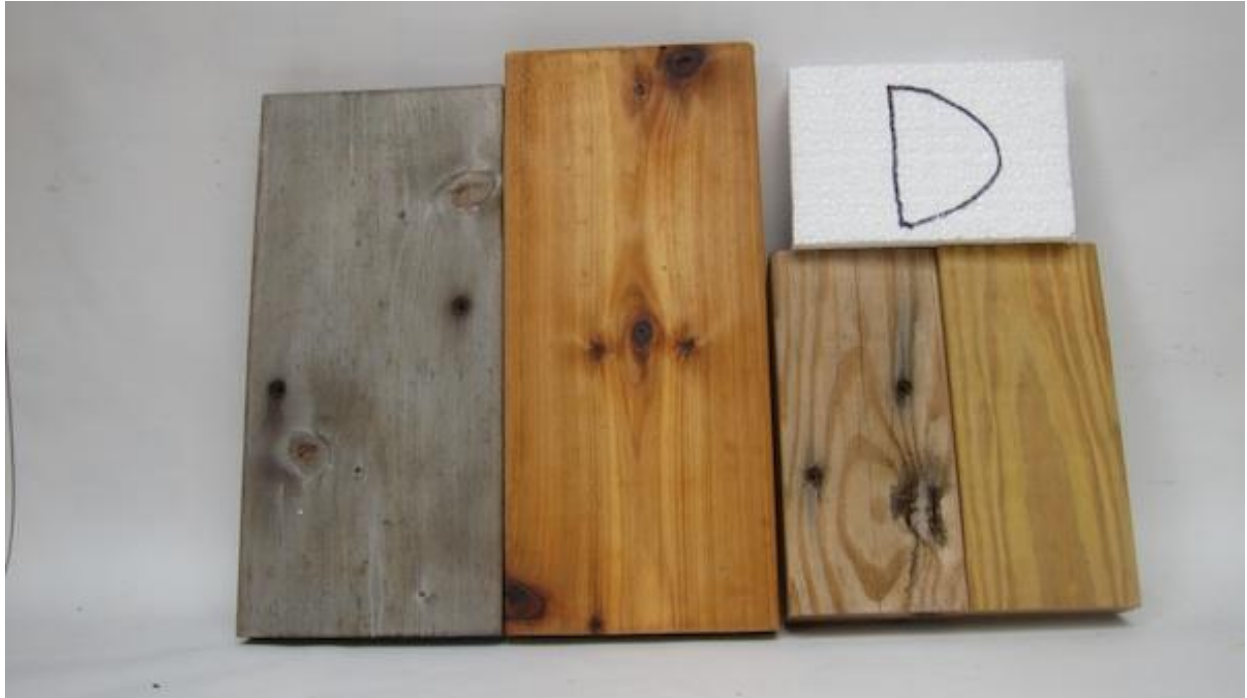
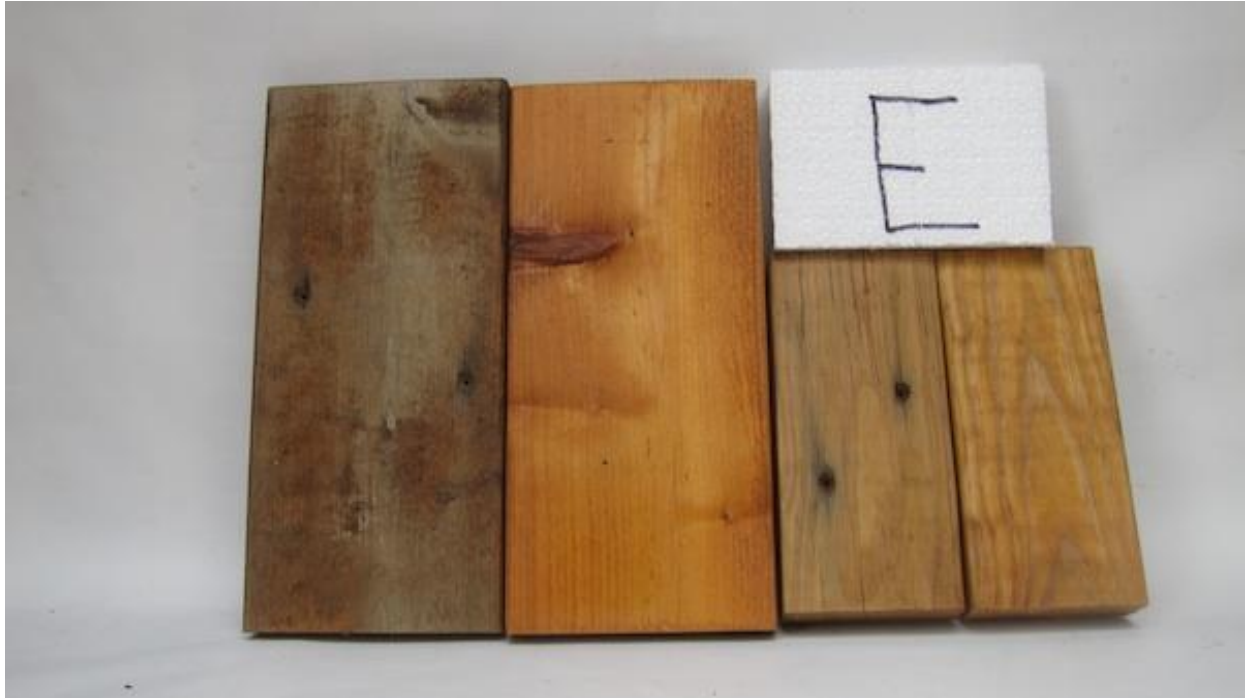
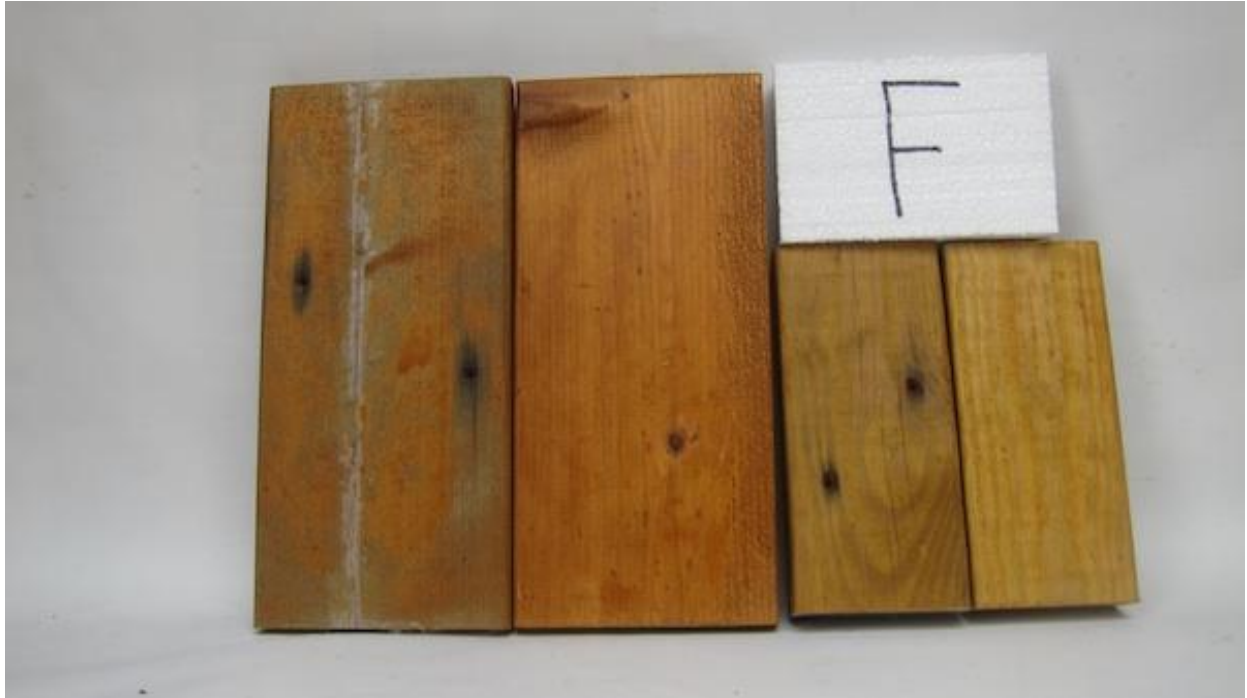
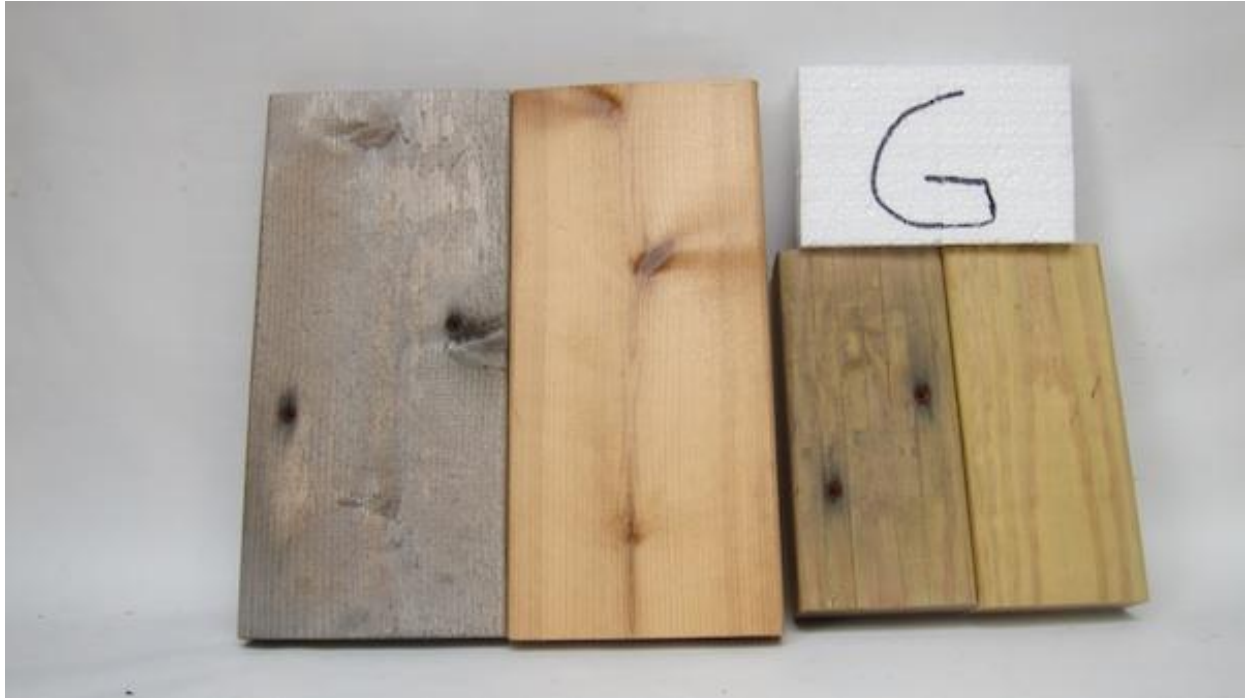
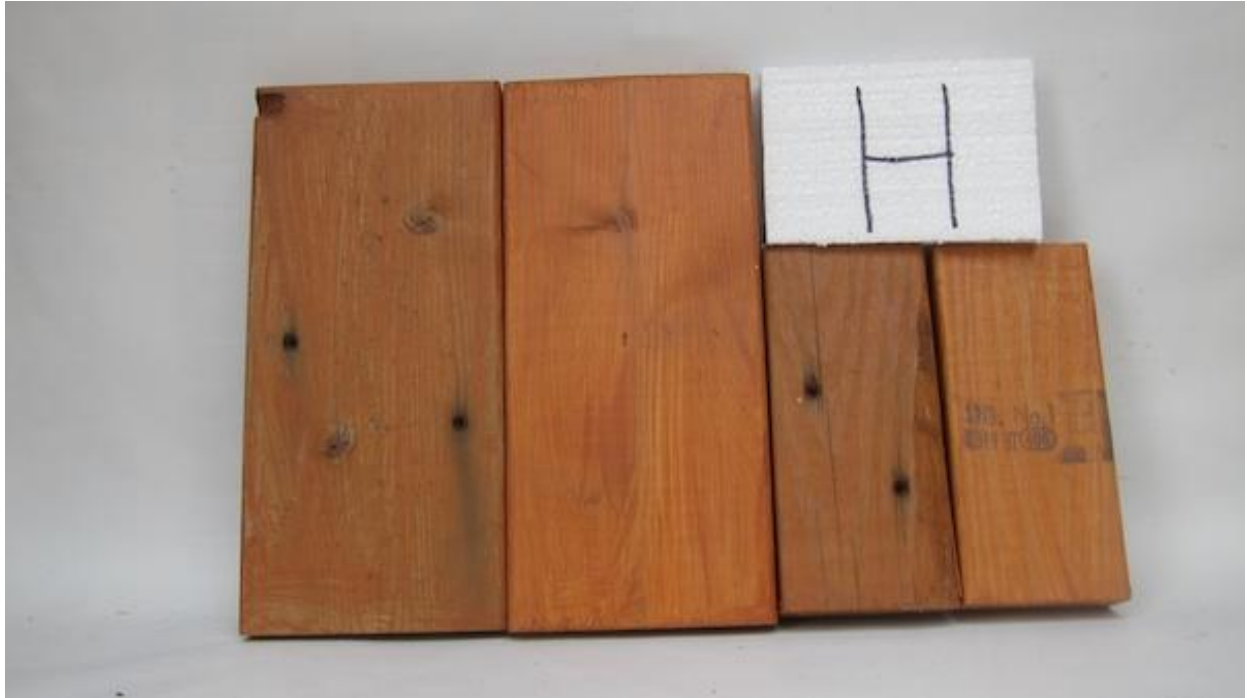
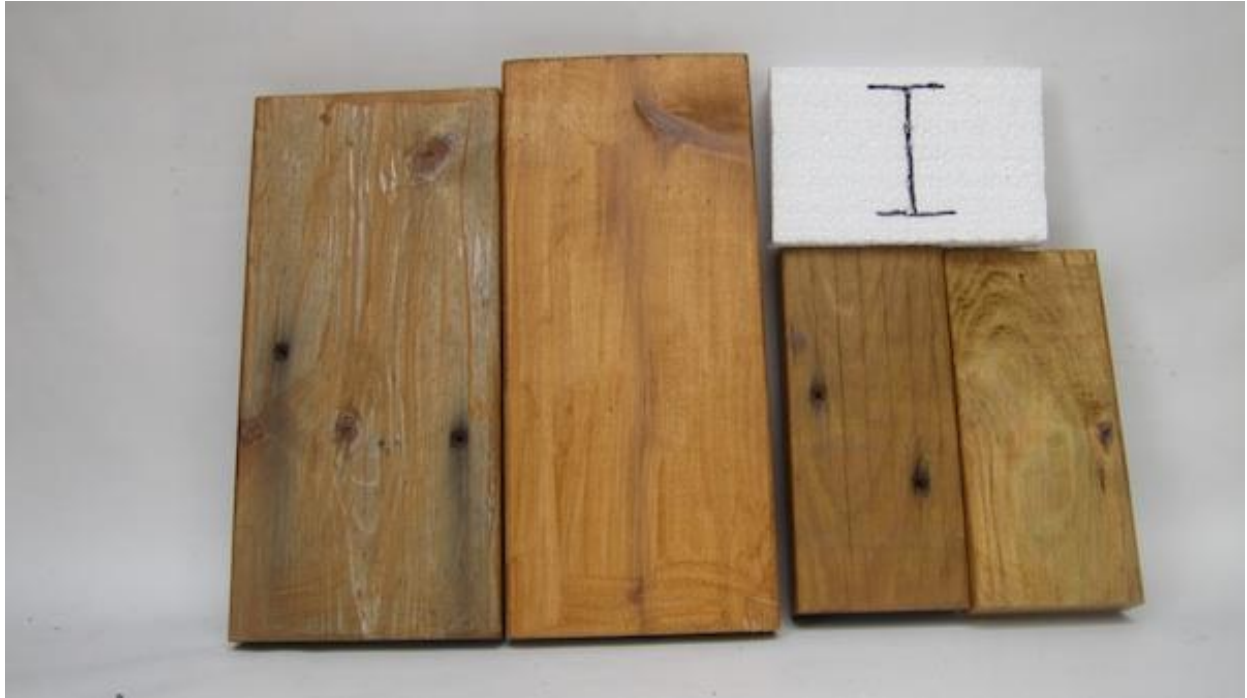
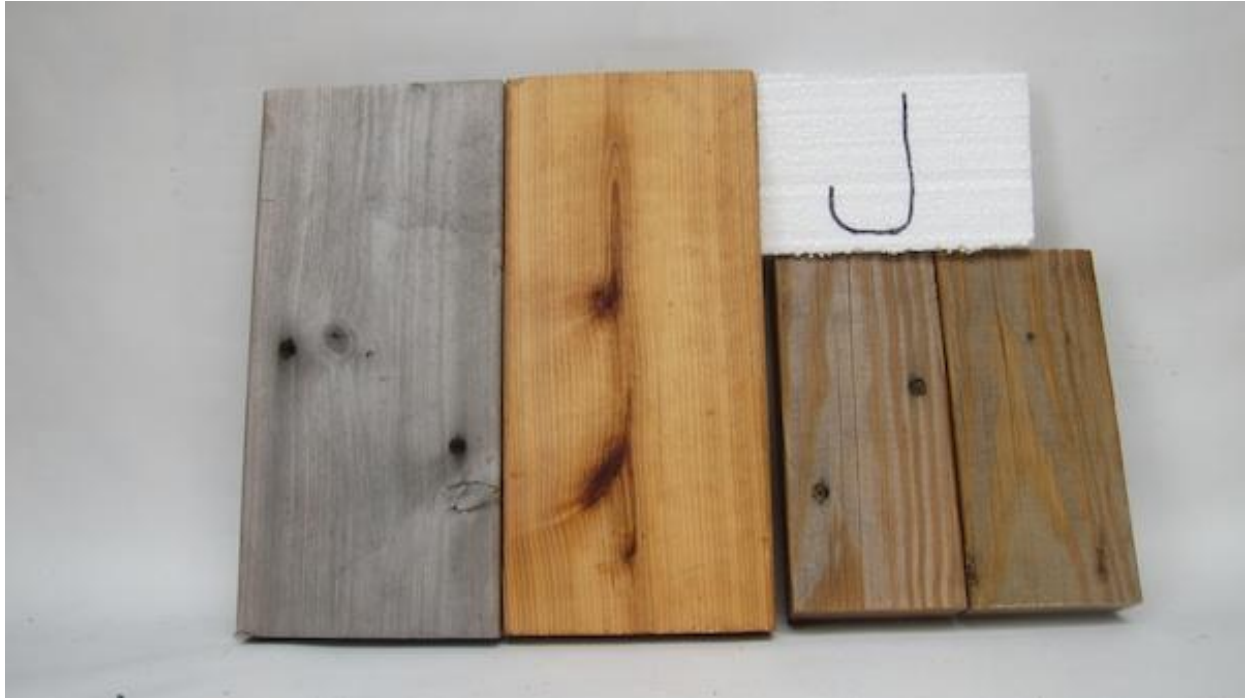
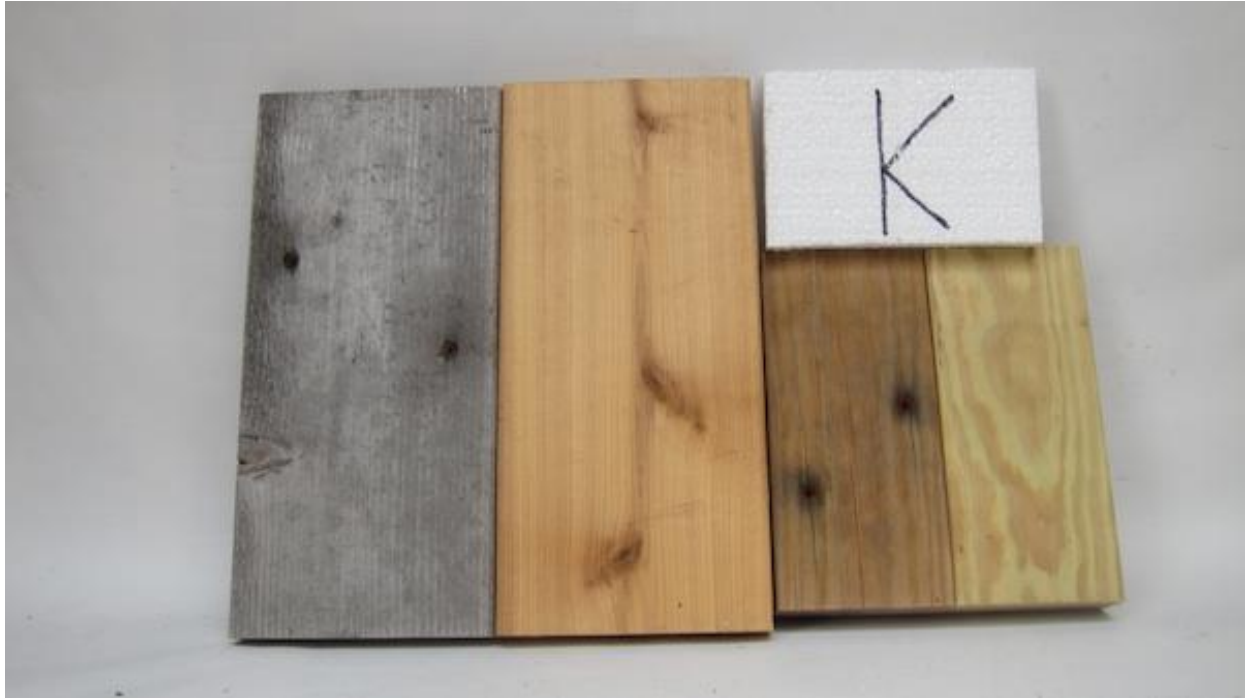
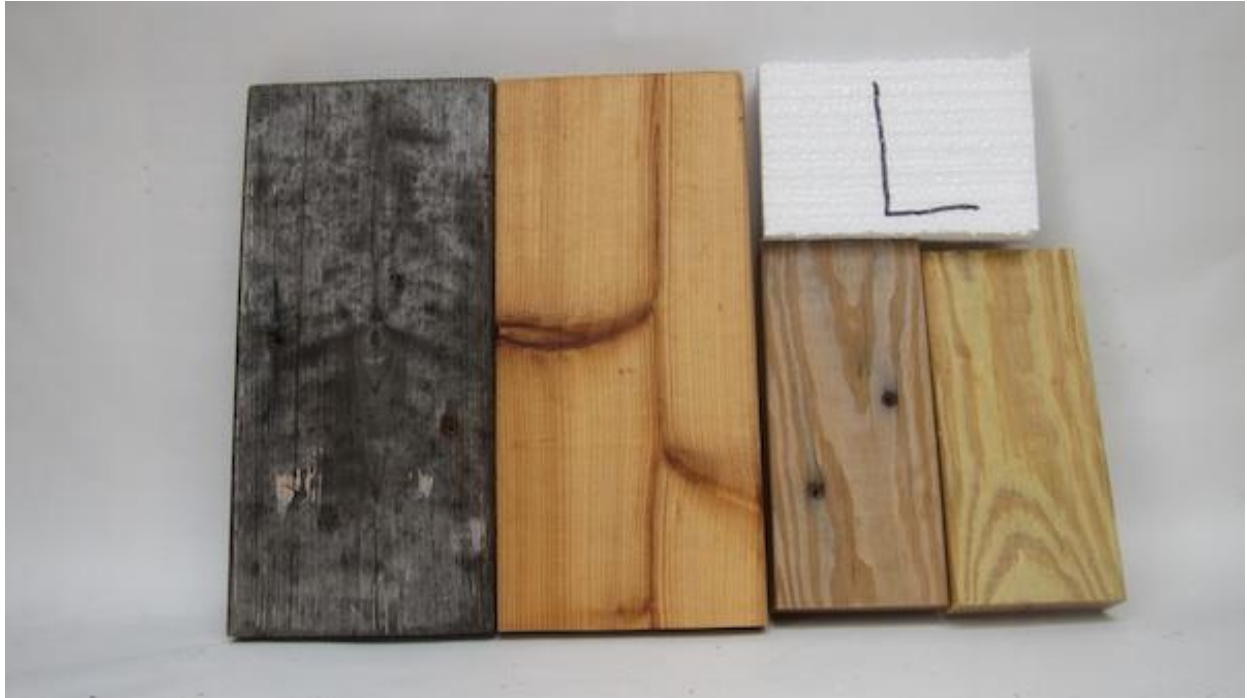
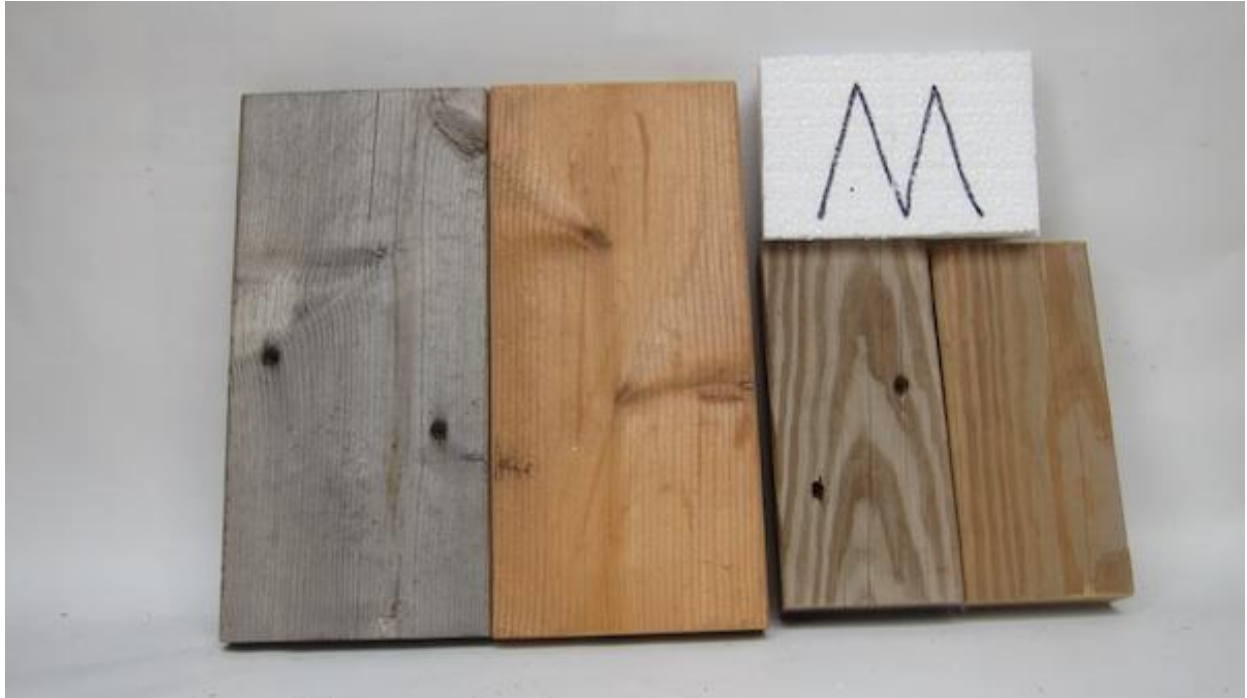
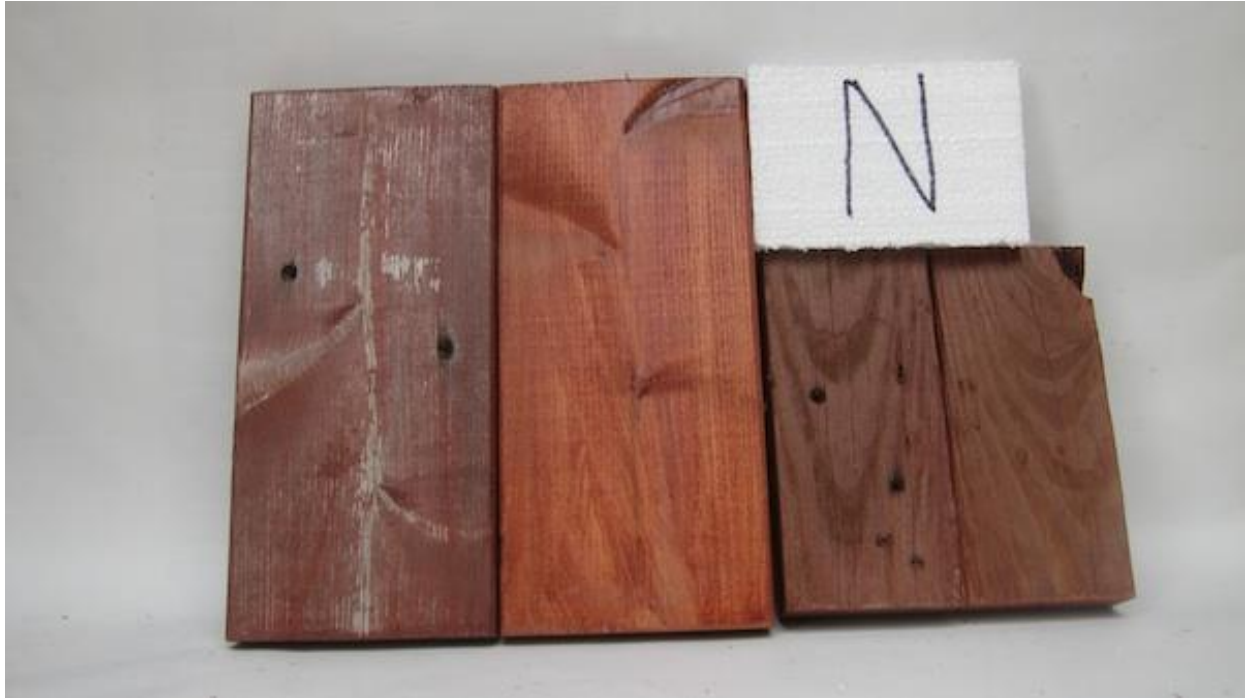
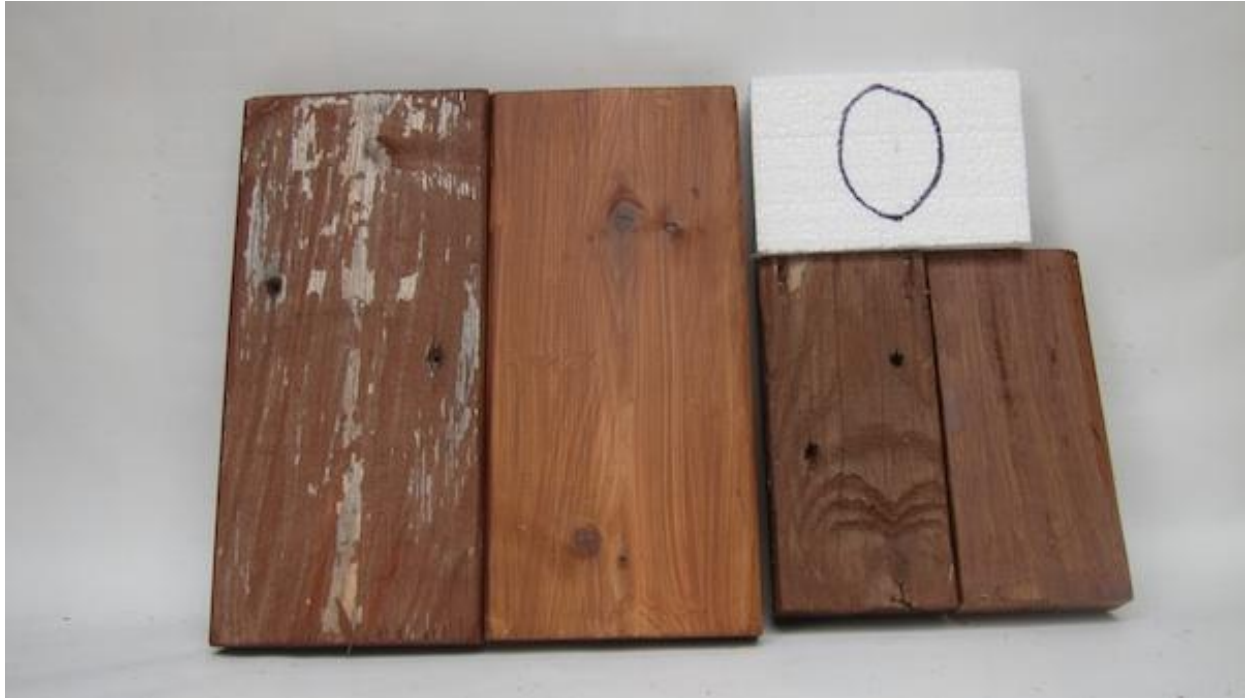
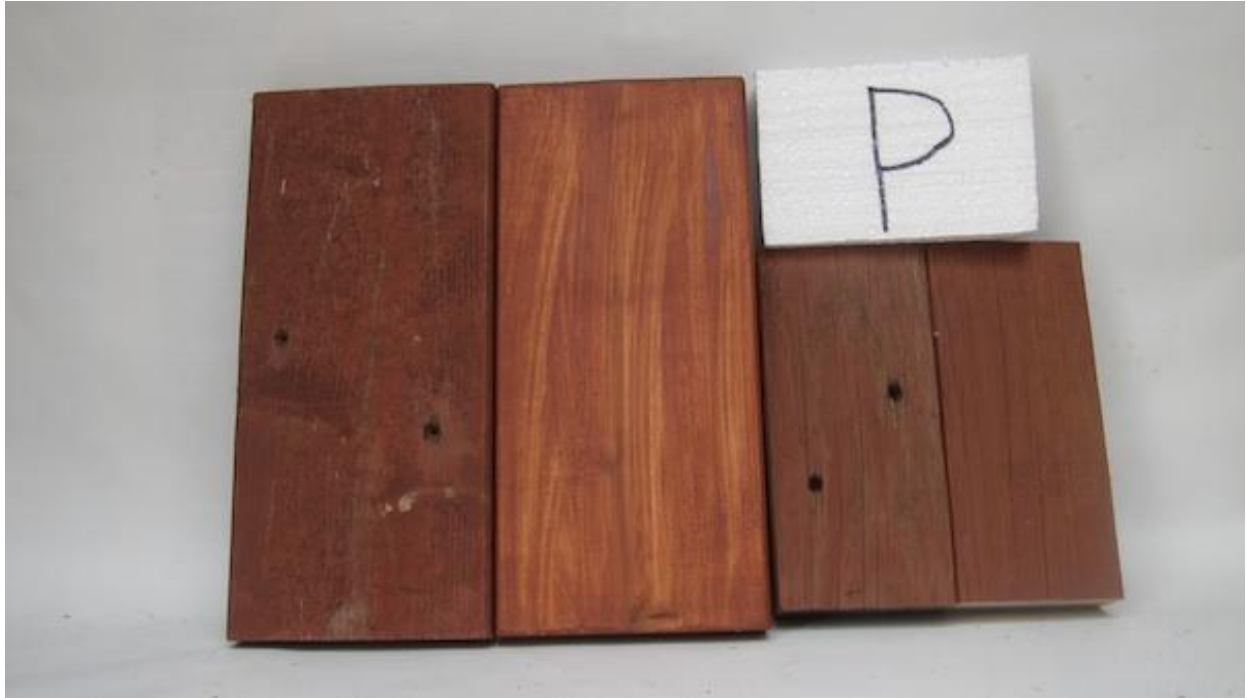
As you look at each photo, you'll see the wider cedar decking on the left and the shorter and narrower pieces of treated pine lumber on the right.

The pieces of wood that were exposed to the weather have two screw holes in each one as they were screwed to a flat 2x4 to simulate resting on a floor joist. They're the left-side samples of each pair (except in sample B where the treated lumber left outdoors is on the far right).
